Low Temperature Thermal Cycle Survivability and Reliability Study for Brushless Motor Drive Electronics

³California Institute of Technology, Jet Propulsion Laboratory

Abstract—^{1,2} This paper presents a survivability and reliability investigation for integrated actuator and brushless motor drive electronics packaging and components under an extreme low temperature and high thermal cycle environment. A universal brushless motor drive electronics assembly has been designed, built, and thermal cycle tested for use in Mars, moon, and asteroid type cold environments without the need for any active thermal control. The assembly uses electronic part types and chip-on-board electronic packaging technology that allow operation at temperatures down to -180°C . The thermal cycle capability of the assembly has been demonstrated to be in excess of 2010 cycles from -120°C to 85°C , over a 210°C total temperature swing. Future space missions will require electronic and actuator systems on a planet, asteroid or moon surface to function beyond the established reliability limits of currently used components and materials systems. In support of this target application, the Jet Propulsion Laborato

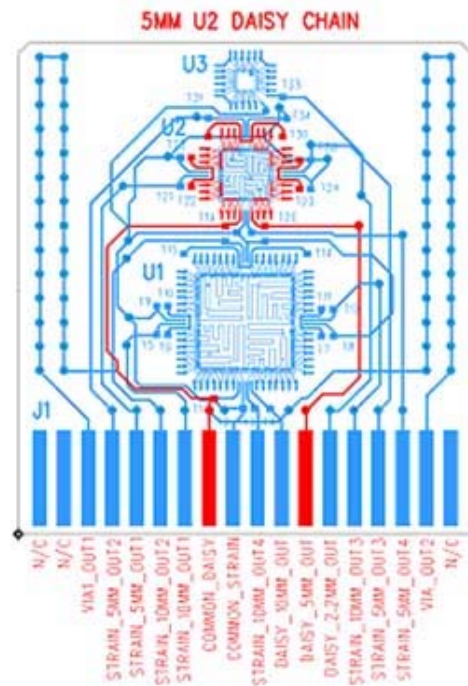
Figure 1: 5 mm die with daisy chain circuit around the perimeter

The 10mm x 10mm and the 5mm x 5mm silicon die had aluminum pads around the perimeter that were provided to allow a daisy chain of wire bonds from the substrate to the die and back multiple times for building a continuous circuit. In addition, each die was fabricated with a strain gage circuit, two per quadrant and eight per die. The 2.2mm x 2.2mm die was fabricated with only pads for building a continuous circuit and did not contain any strain gage circuitry. Figure 1 shows an example of a 5 mm die and the electrical traces that run to it and contain one continuous electrical path daisy chained.

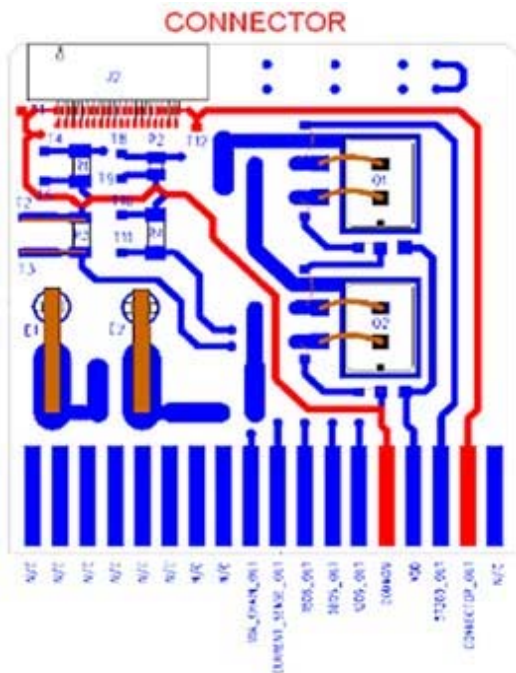
Figure 2: Connector daisy chained circuit

The substrates contained traces that connected each component into one continuous electrical circuit. The 37 nano-connector lead pads and through-hole and buried vias were daisy chained independently into one complete circuit as shown in Figure 2. All four heavy Al wire bond source pads on both MOSFETS were daisy chained with jumper wire bonds in order to complete the circuit between both die.

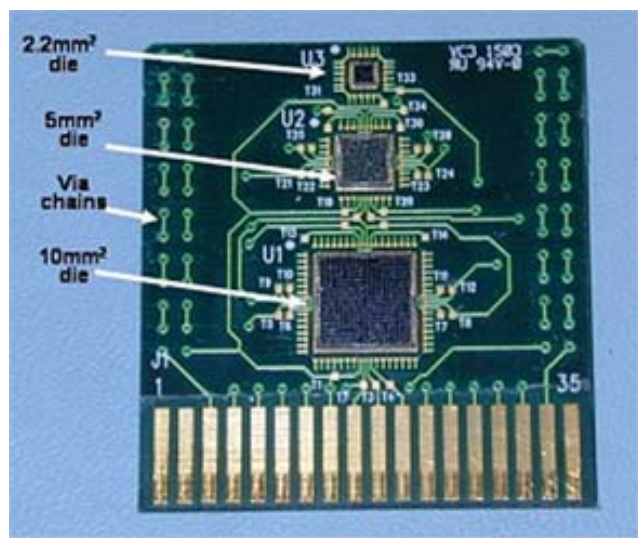
Figure 3: TV1- populated polyimide substrate with electronic components

matrix. Figure 3 illustrates a populated TV1 assembly on polyimide.

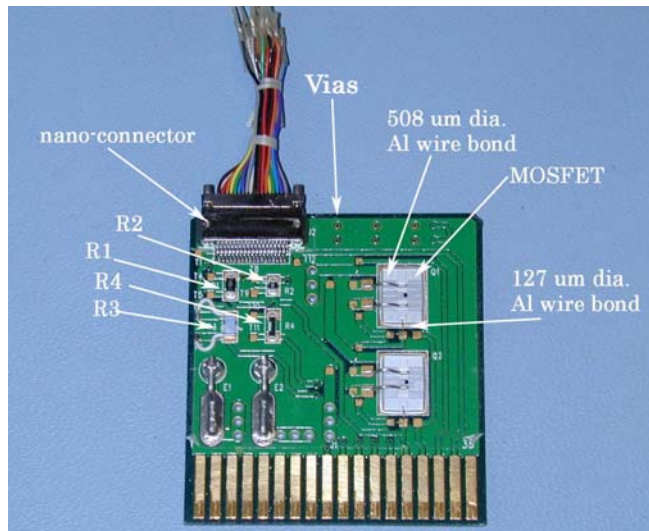
Figure 4: TV2- populated polyimide substrate with

electronic components

Continuity measurements of each component, performed before and after conformal coating deposition, were documented, and reworked. QA inspection occurred at 0 cycles, 500 cycles, 800 cycles, 1000, and 1500 cycles. A fully populated TV2 assembly on polyimide is shown in Figure 4.

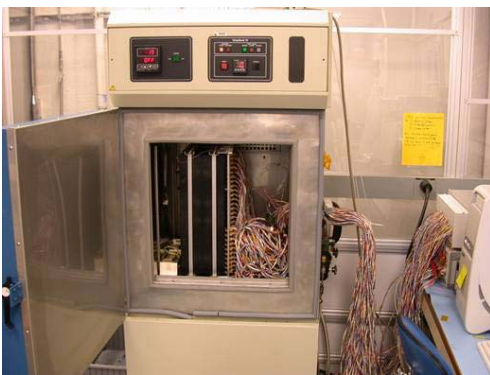
Figure 5: Tenney Model T6C-LN2 Environmental Chamber

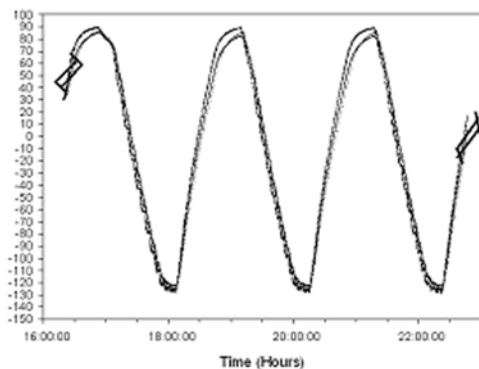
Figure 6: Thermal Cycle temperature profile of thermal couples

Each cycle, programmed between -130°C to 92°C, averaged a 5°C/minute ramp rate. Figure 6 illustrates a typical thermal cycle temperature profile of four thermo-couples. These thermo-couples were used to ensure each test vehicle was subjected to the -120°C to 85°C temperature range. The test vehicles were thermal cycled between -120°C to 85°C and held at each temperature for 10 minutes.

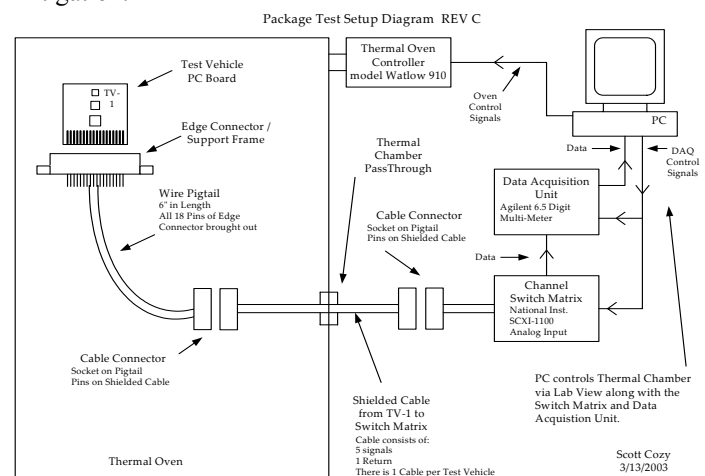
Figure 7: Continuous Monitoring System Schematic

The test vehicles were continuously and periodically manually verified for functionality. A continuous monitoring system schematic is shown in Figure 7. The test monitoring system, located adjacent to the test chamber, had the capability of continuously monitoring 48 test vehicles simultaneously. The continuity circuits were measured for resistance three times per second and the raw resistance data was recorded on compact disk by a host computer or DAQ (Data Acquisition) system. This measuring method allowed the team to detect the beginning of an "open" failure if it was opening and closing during temperature cycling prior to remaining open with a definitive fracture. The cabling from

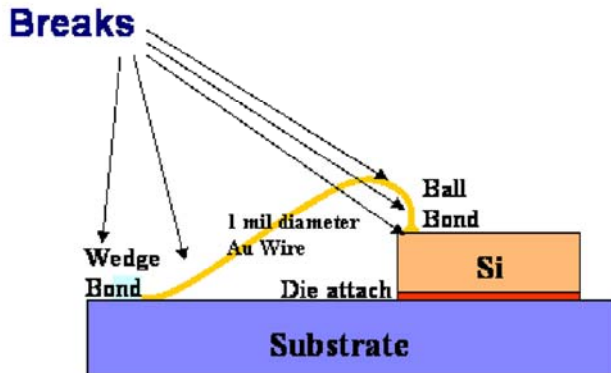
Figure 8: TV1 Five Failure Modes

to the wire bond itself in all cases. There were 5 different types of failure modes or breaks identified within the wire bond die to substrate interface as shown in Figure 8. The initial wire bond failures or circuit opens were identified at the peak or near the middle of the wire bond curve. These were observed using non-destructive X-Ray. Wire bond failures were observed several wire diameters away from the ball bond and the wedge bond, again with non-destructive X-Ray. During decapsulation of selected test vehicles, where X-Ray did not reveal any reason for a failure or open circuit, additional failure modes were observed at the ball to die and wedge to substrate interfaces.

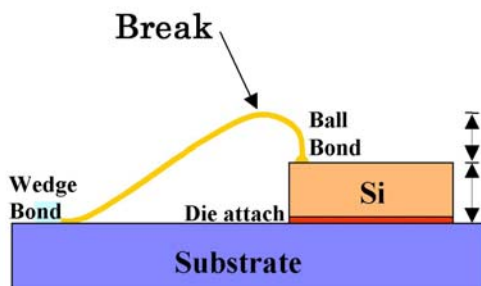
Figure 9: Location of break near the wire bond peak

For example, the illustration in Figure 9 shows the location of the open or break at or near the wire bond peak in a cross sectional view. An X-Ray image of the actual open in a test vehicle that was encapsulated with Hysol epoxy FP-4402 is shown in Figure 10.

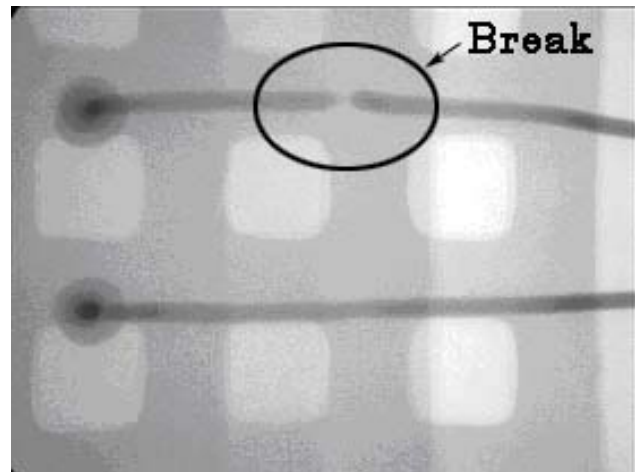
Figure 10: Fein Focus X-Ray of break near the wire bond peak

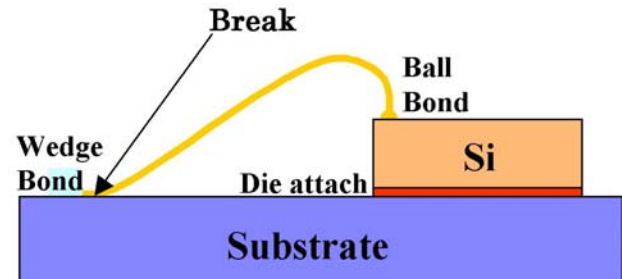
Figure 11: Location of the break at the wedge bond on the substrate

The illustration in Figure 11 & 12 shows the location of the open or break at the wedge bond to the substrate pad interface in a cross sectional view and in the high magnification picture of the actual open in a test vehicle that was decapsulated. For example, the SN: 10231332-9 lot shown in Table 5 failed after an electrical open occurred due to the Au wedge bond lifting from the Au pad (shown in Figure 12) on the substrate. The failure mode of the SN: 10231334-3 lot that failed after 2295 cycles is still under investigation.

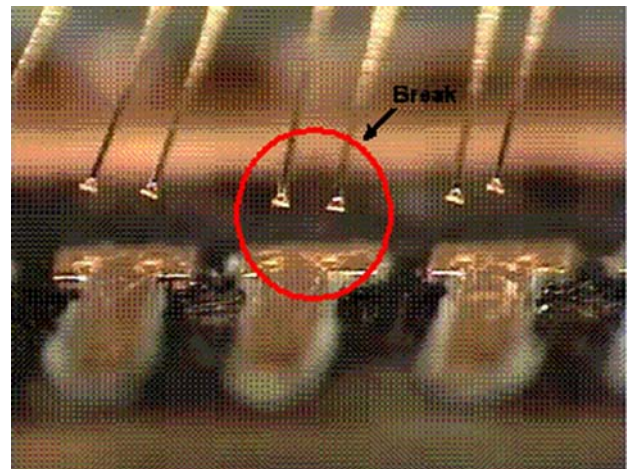
Figure 12: High Magnification of break at the wedge bond

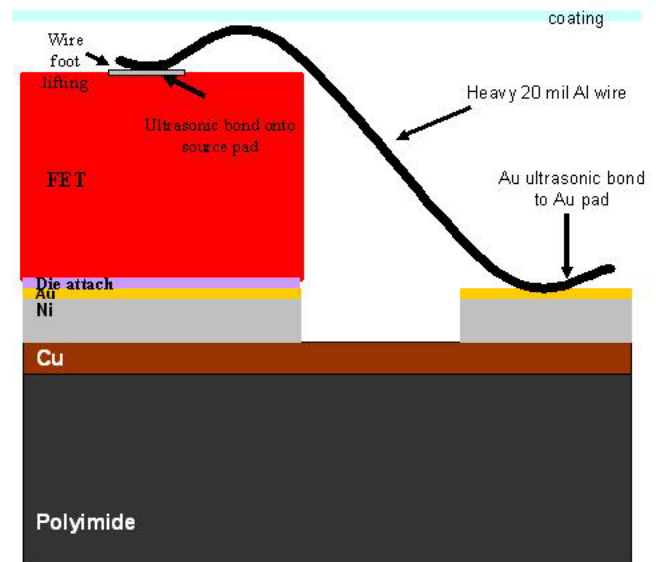
Figure 13: Schematic of Heavy Al wire bonded to MOSFET and Au Pad

The failure mode was related to micro-cracking which lead to lifting. Fatigue cracking occurred due to thermal stress generated by the thermal coefficient of expansion mismatch between the MOSFET die composed of Si (CTE = 2.49 μ m/m- $^{\circ}$ C linear at 20 C)⁶ and the 100% pure Al (CTE = 24 μ m/m- $^{\circ}$ C linear at 20 C)⁷ wedge bond [2] and Δ T.

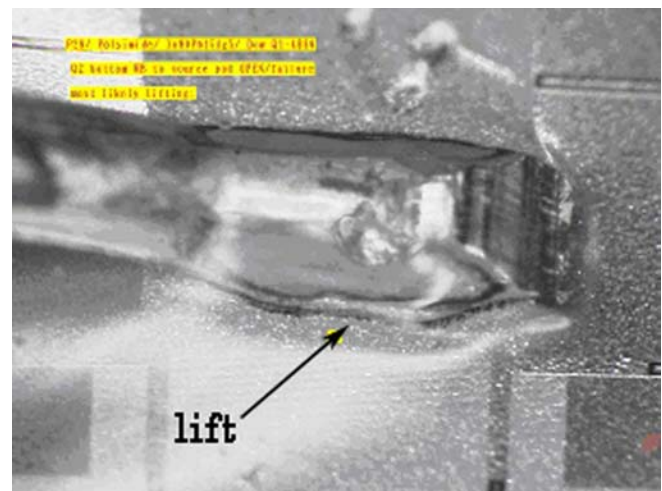
Figure 14: Top View of P029 Wire bond to Source Pad Lifting (175x)

6.3 MOSFET 508 μ m Heavy Al Wire Bond Lifting—All material combinations of 508 μ m in diameter heavy Al wire bonds have failed on each substrate. Failures began on polyimide between 638-863 cycles, and on thick-film alumina and LTCC between 623-1316 cycles. Electrical opens occurred due to wedge bond lifting from the MOSFET source pad. Figure 13 details the area of interest and Figure 14 shows the lifted wire bond foot on the same area. Figures 15 and 16 show a failed Al wire wedge bond interface on top of the die source pad.

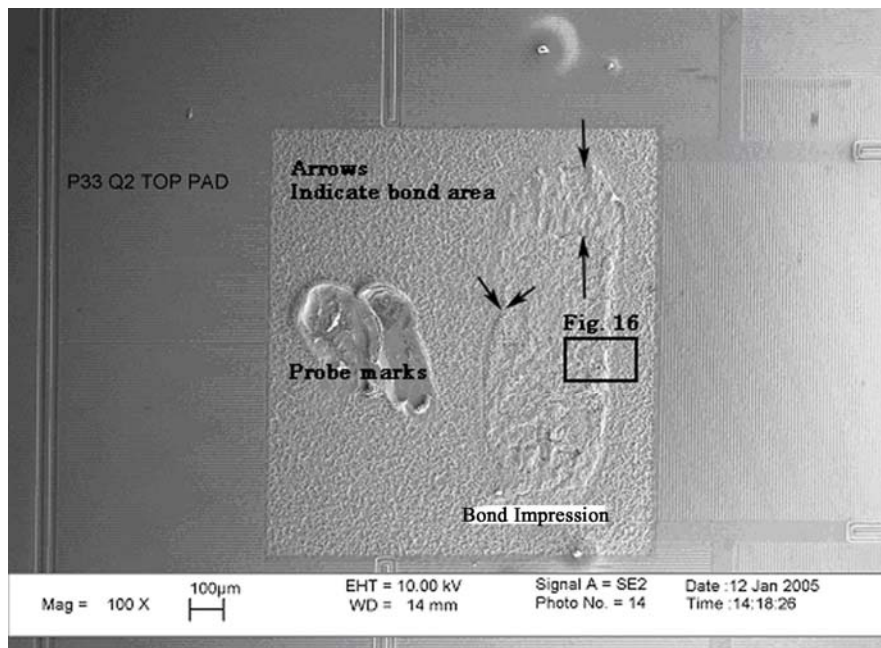
Figure 15: SEM of Failed Resgion at the source pad bond (100x and 10keV)

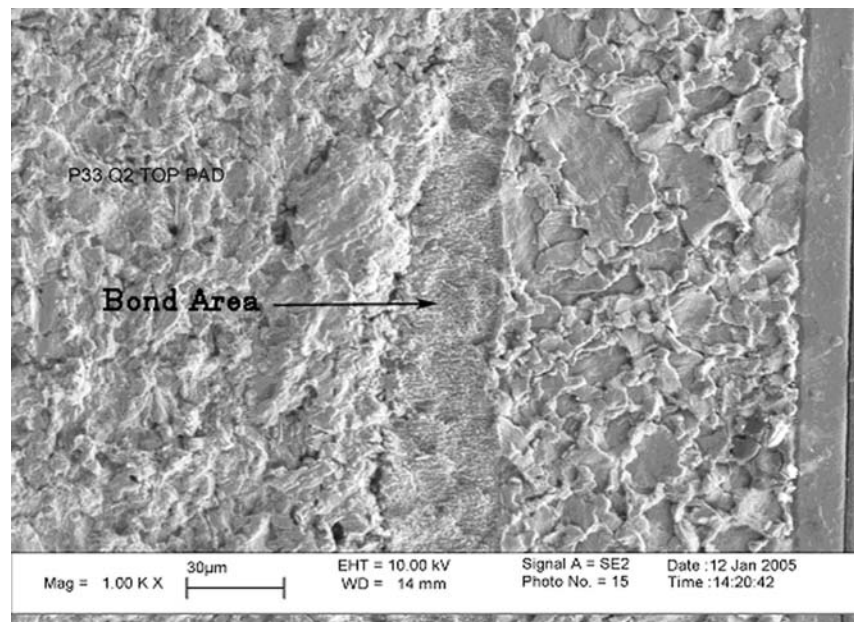
Figure 16: Detailed SEM view of failed region where wire lifted (Mag-1kx and 10keV)

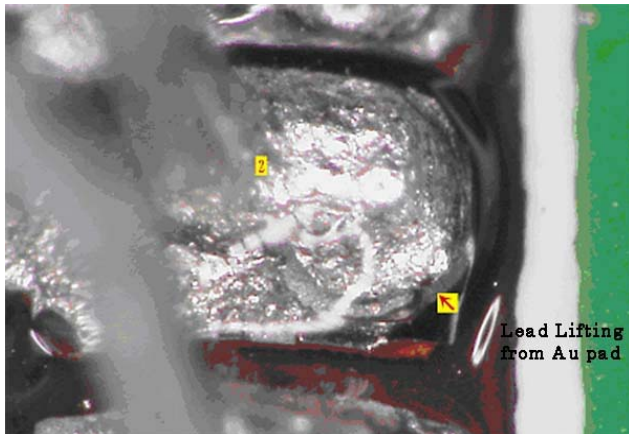
Figure 17: Top view lead lifting on PWB- P048 at 175x

Figure 17 shows a top view of a lead and subsequent cracking along the interface of the foot and the Au pad which failed between 638 and 863 cycles. The cracking along the interface caused lead lifting.

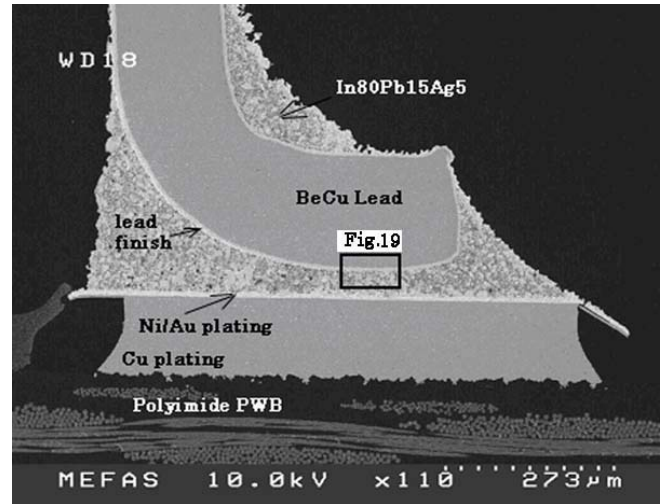
Figure 18: SEM cross- section of a lead that did not fail on polyimide at 10x and 10keV

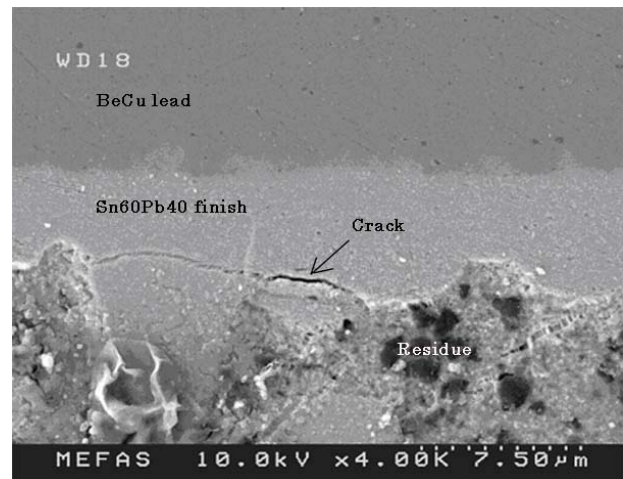
Figure 19: SEM cross- section of probable crack initiation site on polyimide at 4kx/10keV (inset from Fig. 18)

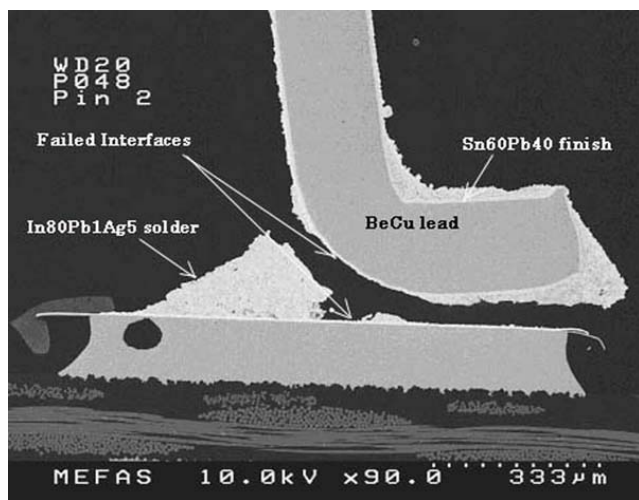
Figure 20: SEM cross- section of failed lead on polyimide at 90x/ 10keV

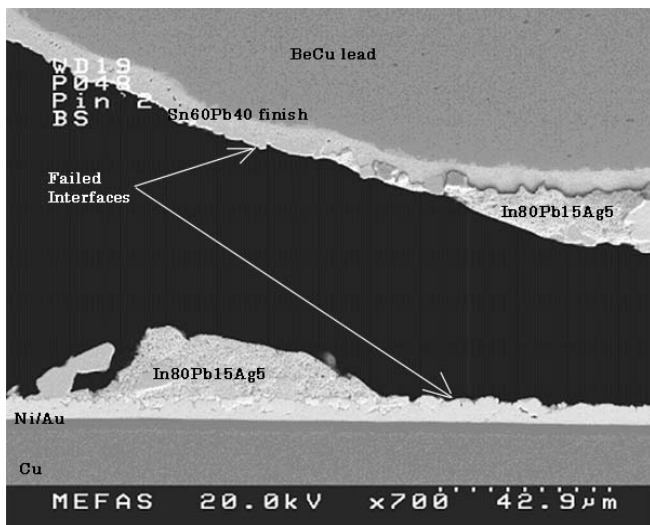
Figure 21: Back-scatter image of failed interfaces at 700x/20keV

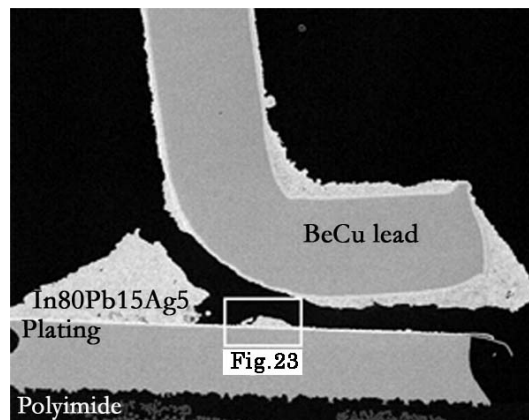
Figure 22: SEM cross- section of intermetallic analysis location at 90x/10keV

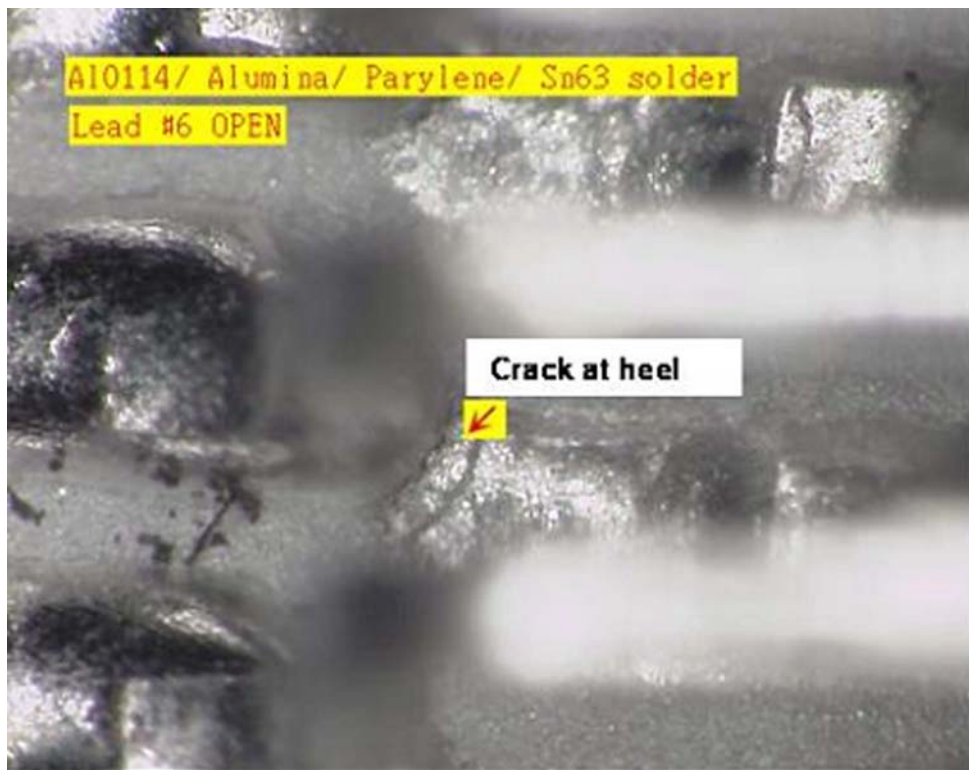
Figure 24: Top View of Crack at Heel of Lead #6 in the front with Sn63 solder on Alumina and Parylene Coating (175x)

Crack initiation and propagation occurred within the eutectic Sn63Pb37 solder that was used on the connector leads. Visual inspection revealed a crack at the heel fillet, highest stress point, as shown in Figure 24 at lead #6 of the failed pair, #6 and #31 that are daisy chained. SEM analysis revealed cracks under the heel of both leads #6 and #31. Crack propagation occurred near the plating interface in the solder in both Pb (light region) and Sn (dark region) phases. However, it is more likely that the cracks began in the Sn phase due to the phase transformation and brittle nature of tin at low temperatures. Figures 25 and 26 show several cracks through the solder under the lead foot and finish of leads #6 and #31. The cracks within the trace in from the lead in Figure 26 were caused from sample preparation.

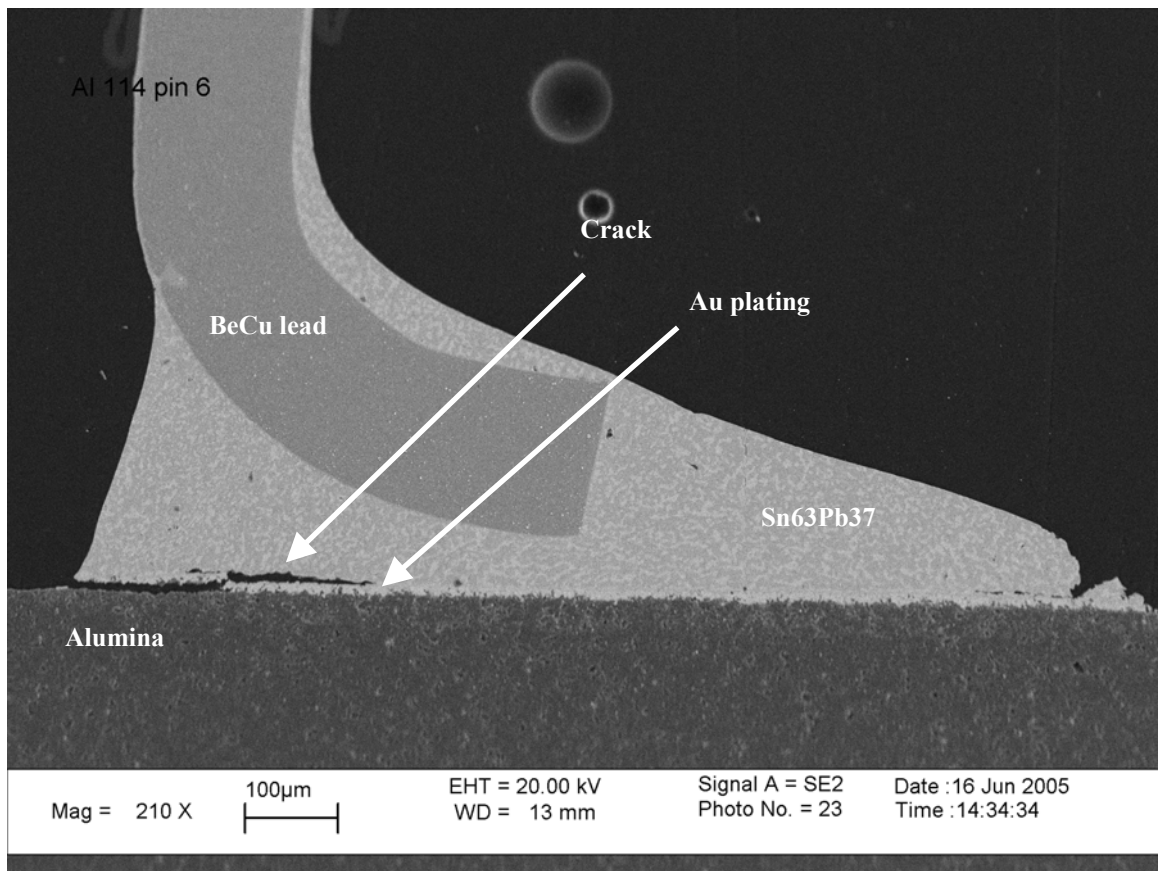
Figure 25: SEM Cross-Section of Al114 Failed Lead Foot #6 in the front at Mag- 210x and 20keV

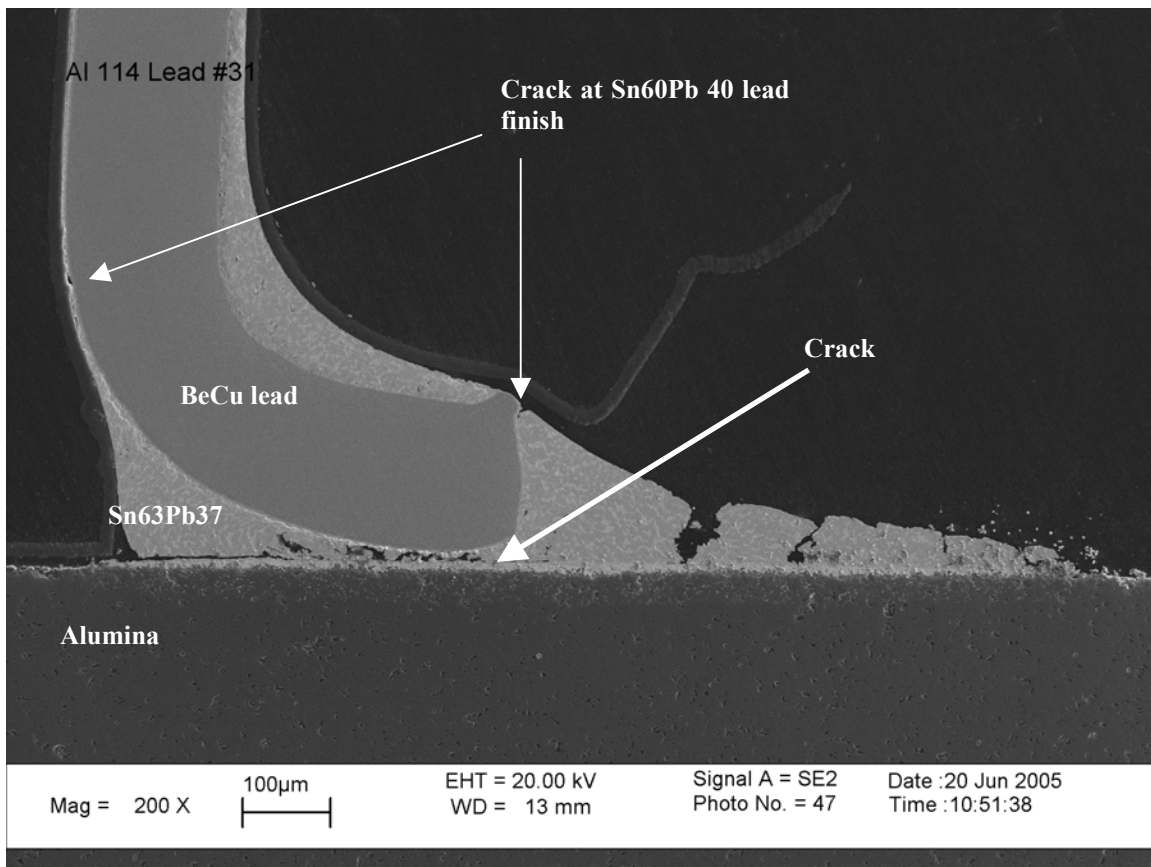
Figure 26: SEM Cross-Section of Al114 Failed Lead Foot #31 in the back at Mag- 200x and 20keV

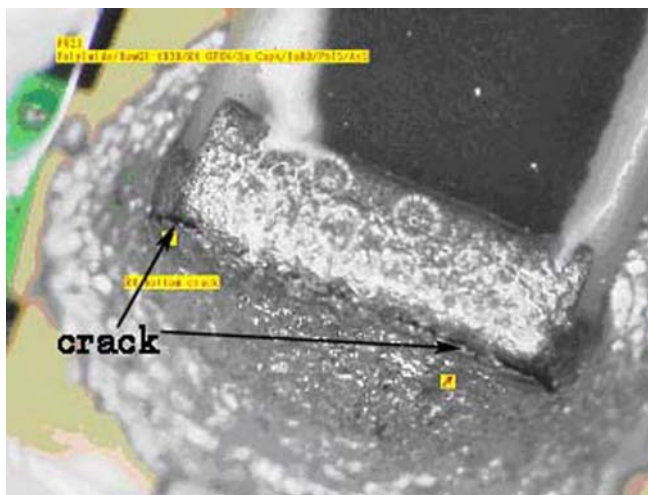
Figure 28: Top View of R4 Sn/Pb/Ag Finish Endcap Cracking using In80/Pb15/Ag5 Solder on Polyimide (175x)

6.5 R4 Resistor Endcap Cracking—Electrically open circuits have occurred at the R4 resistor with Sn62Pb36Ag2 finish and In80Pb15Ag5 solder starting between 0-563 cycles on polyimide. The failure mode is related to cracking through the endcap solder as shown in Figure 28. The failure mechanism occurred due to the absence of a Ni layer which cannot structurally hold the solder, as shown in Figure 29. A Ni layer functions as an adhesion layer and interdiffusion barrier. This resistor had the largest package size, 1506, which induced the highest thermal stress.

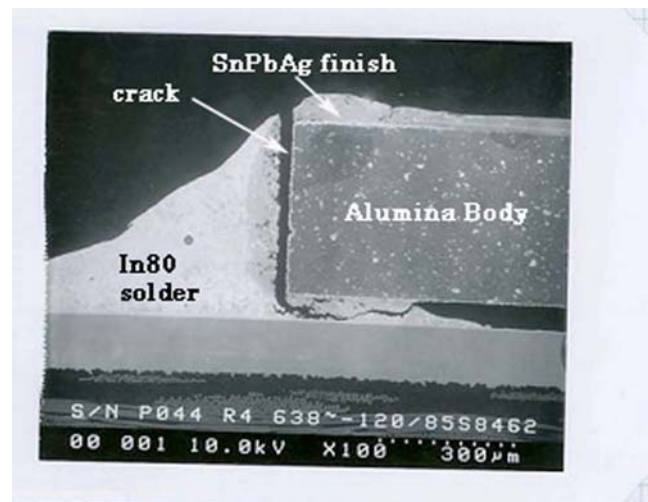
Figure 29: SEM Cross- Section View of R4 Endcap Cracking at Mag-100x and 10keV

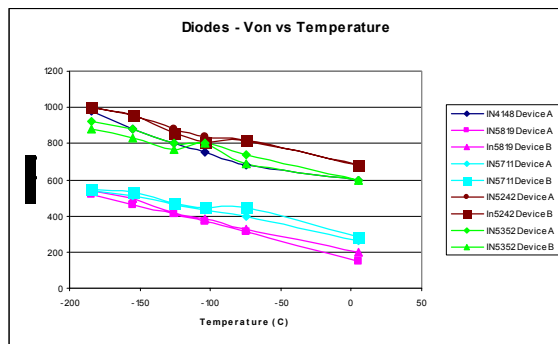
Figure 30. Von as a function of temperature.

Shown in Figure 30, the V_{on} of IN4148, IN5819 and IN5711 has at least 100% change over the temperature while V_{on} of IN5242 and IN5352 have about 45~50% change at the same temperature range. The change of the reverse breakdown voltage is more consistent for all diodes, which shows an overall 15~20% decrease from 5°C to -180°C .

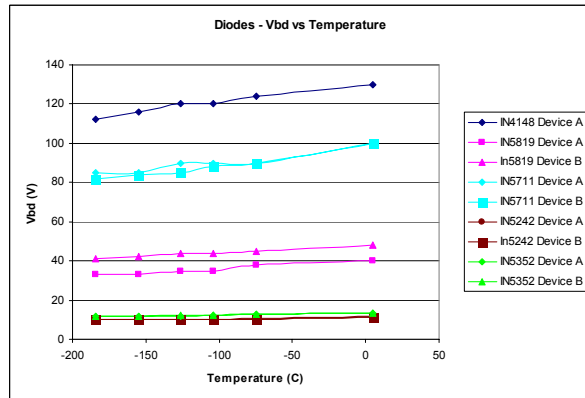
Figure 31. Vbd as a function of temperature.

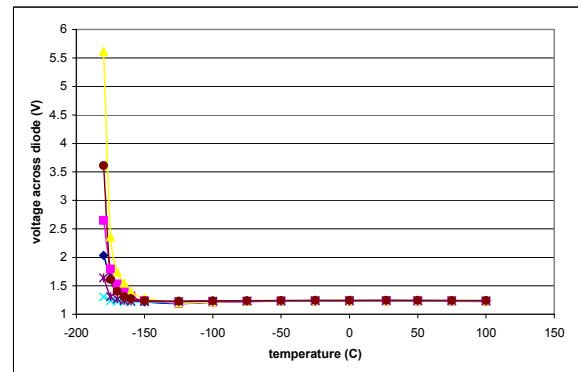
Figure 32. Voltage at different current biases as a function of temperature for LM185-1.2.

threshold for all three diodes. The difference is LM185s began to have over 10% change below -150°C, while LT1029 was operating with approximately 50mV change down to -180°C.

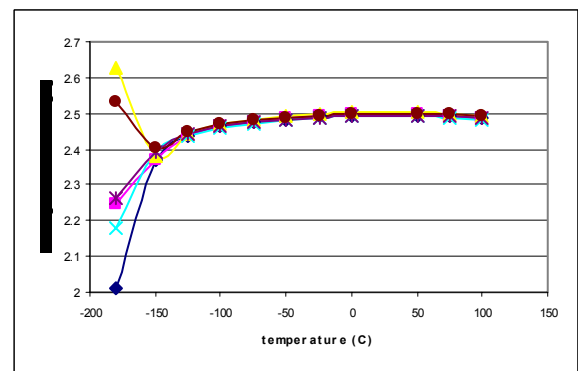
Figure 33. Voltage at different current biases as a function of temperature for LM185-2.5.

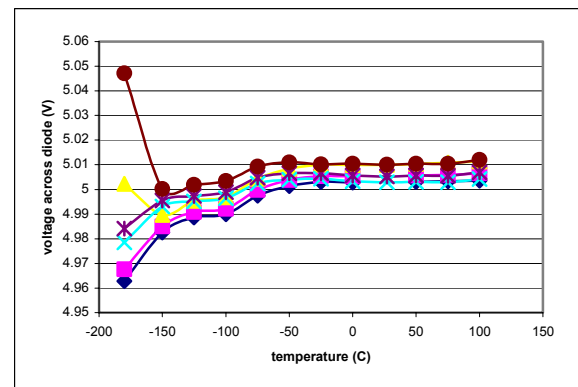
Figure 34. Voltage at different current biases as a function of temperature for LT1029.

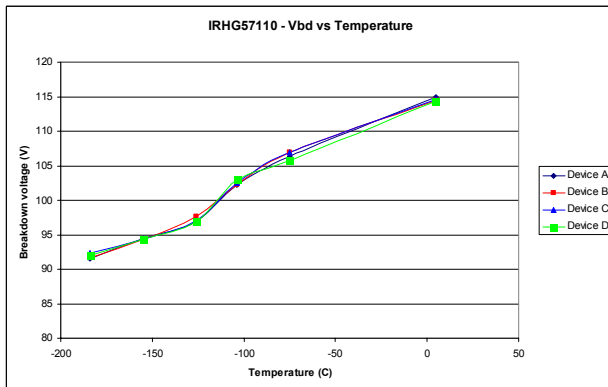
Figure 35. V_{bd} of IRHG57110 as a function of temperature.

Figures 35-37 plot the V_{bd} , R_{dson} and V_{th} as a function of temperature and show a clear trend of temperature dependence of these parameters.

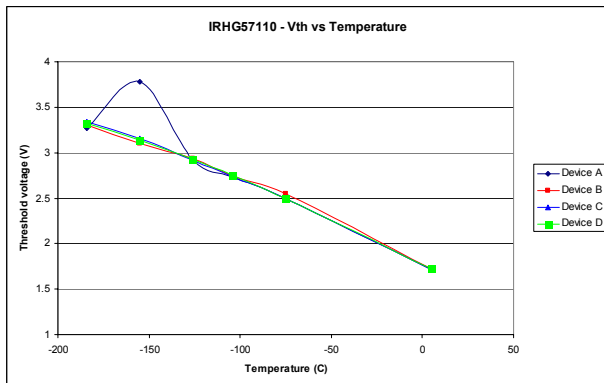
Figure 36. V_{th} of IRHG57110 as a function of temperature.

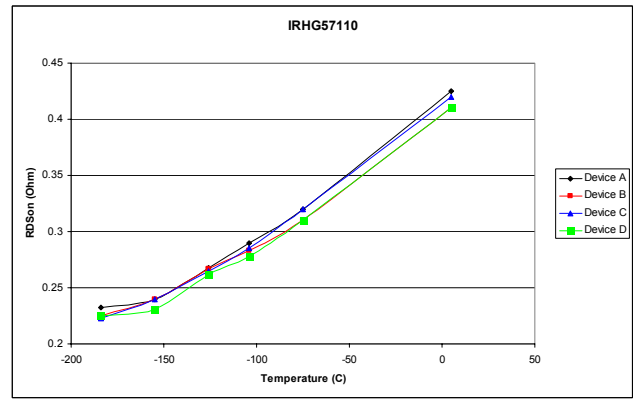
Figure 37. R_{dson} of IRHG57110 as a function of temperature.

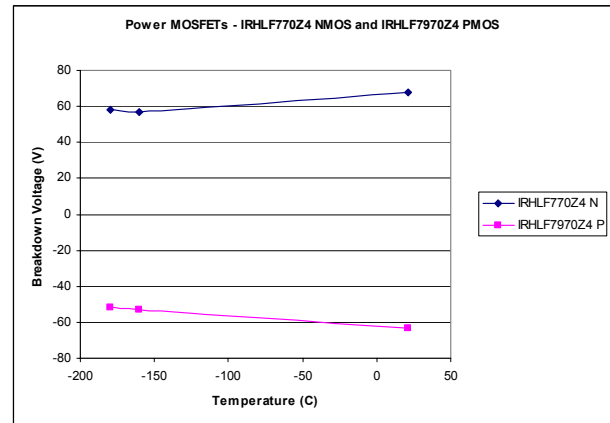
Figure 35(a). V_{bd} as a function of temperature.

In addition, one IRHLF77024 and one IRHLF797024 were tested by an HP4145B at temperatures ranging from 22°C to -180°C . The R_{dson} was calculated at $I_{\text{d}}=100\text{ mA}$ and V_{th} was measured when $V_{\text{ds}}=100\text{ mV}$ with V_{gs} sweeping from 0 to 3V in 10mV steps. The breakdown voltage, R_{dson} and V_{th} as function of temperature are given in Figures 35(a), 36(a) and 37(a).

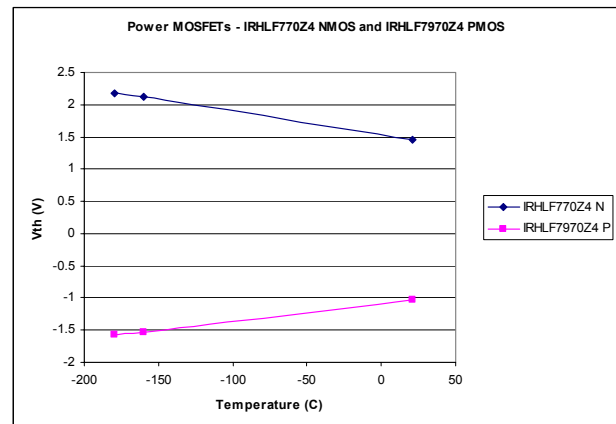
Figure 36(a). V_{th} as a function of temperature.

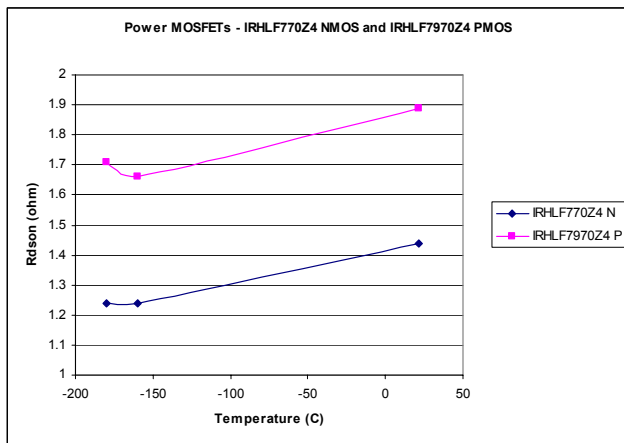
Figure 37(a). Rdson as a function of temperature.

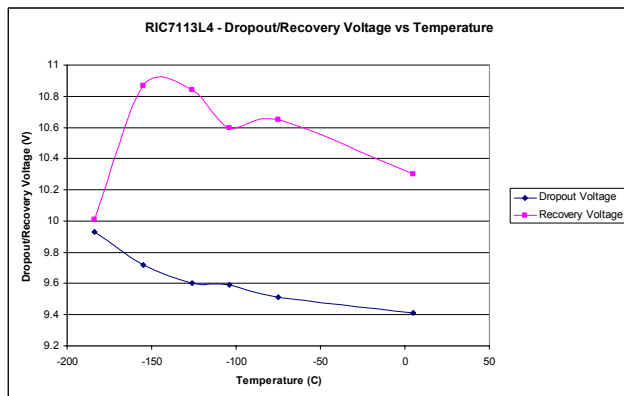
Figure 38. Dropout/Recovery voltage of RIC7113A4 as a function of temperature.

Keeping the 5V logic supply voltage unchanged, the gate drive voltage was then reduced gradually to a point when the devices stopped outputting. This gate drive is defined as the dropout voltage. Then the gate drive voltage supply was increased gradually to a point when the devices started outputting again. This gate drive is denoted as recovery voltage, shown in Figure 38 as function temperature.

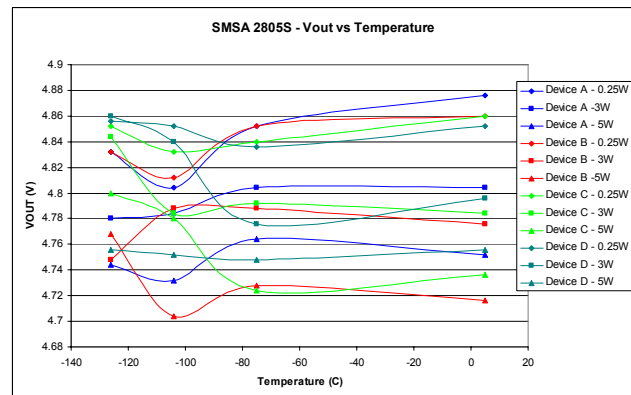
Figure 39. Output voltage of SMSA 2805S as a function of temperature.

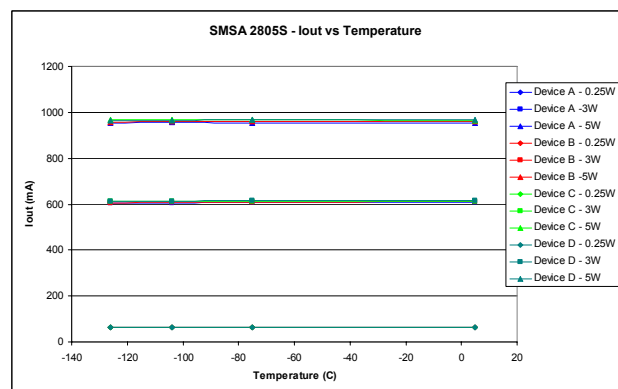
Figure 40. Output current of SMSA 2805S as a function of temperature.

Output current and input current without load are much consistent with temperature with input current starting to go up with lower output power, shown in Figures 40 and 41.

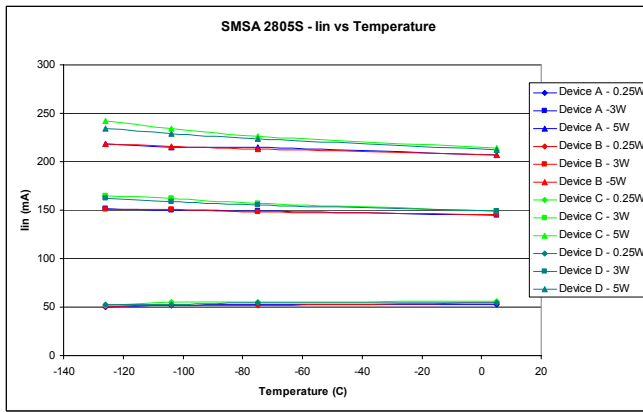
Figure 41. Input current of SMTA 2805S as a function of temperature.

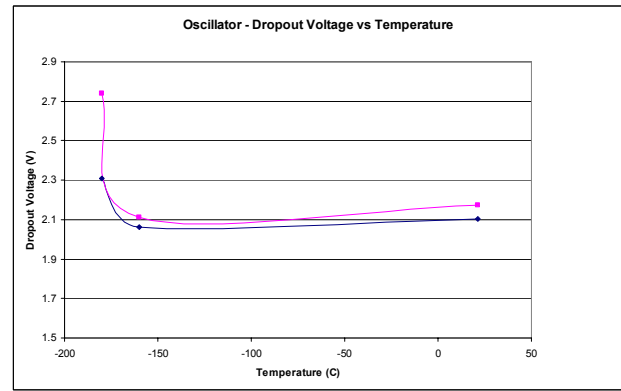
Figure 42. Dropout voltage as a function of temperature.

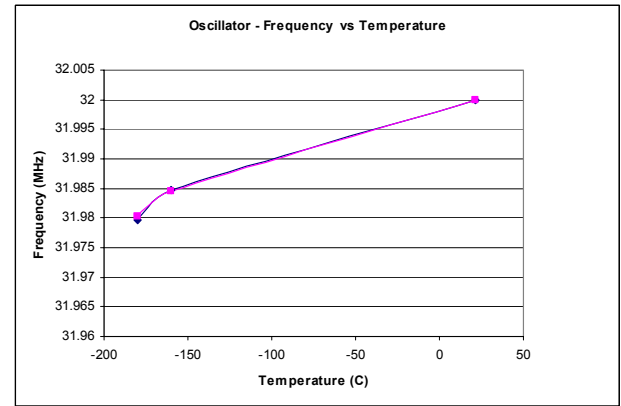
Figure 43. Frequency as a function of temperature.

There is approximately 0.06% change of the frequency over the temperature.

A sample size of two oscillators, both VPC1-E3F-32M, were tested using a Power Supply HP 6235A for biasing and a frequency counter, Stanford Research Space Model SR620, and DMM Fluke Model 87V over temperature range of 22°C to -180°C. Figures 42, 43, 44, and 45 give the dropout voltage, frequency, disabled supply input current and enabled supply input current as function of temperature, respectively. Except for the enabled supply input current which shows significant variations between the two test samples, other parameters matched well and display clear temperature dependence.

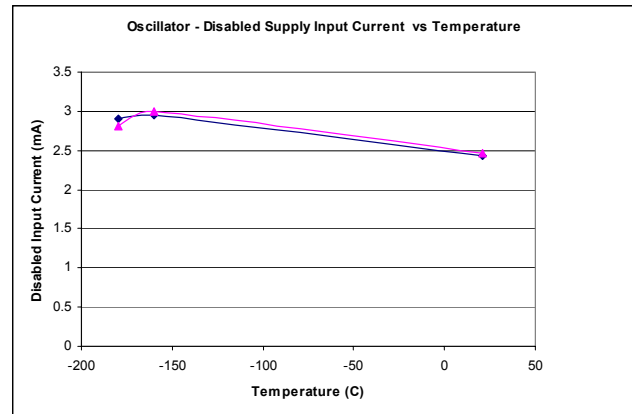
Figure 44. Disabled supply input current as a function of temperature.

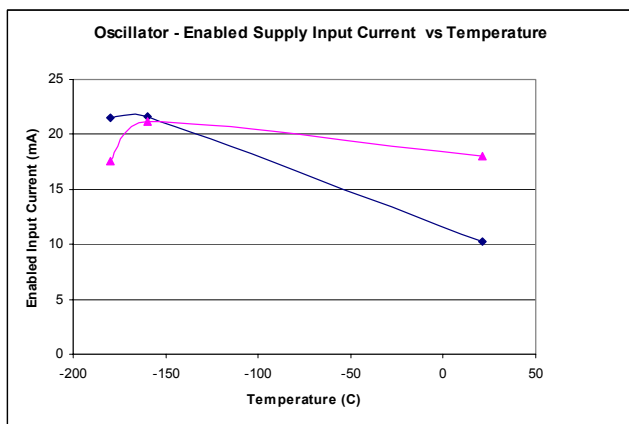
Figure 45. Enabled supply input current as a function of temperature.

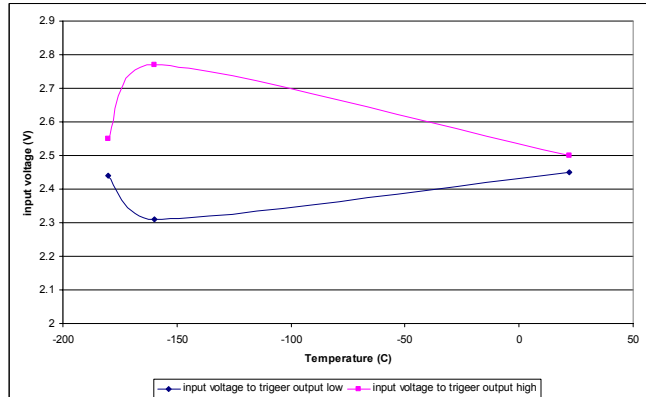
Figure 46. Input voltage to trigger output high and output low as a function of temperature.

Figure 46 shows the input voltage to trigger the output high and the input voltage to trigger the output as a function of temperature.

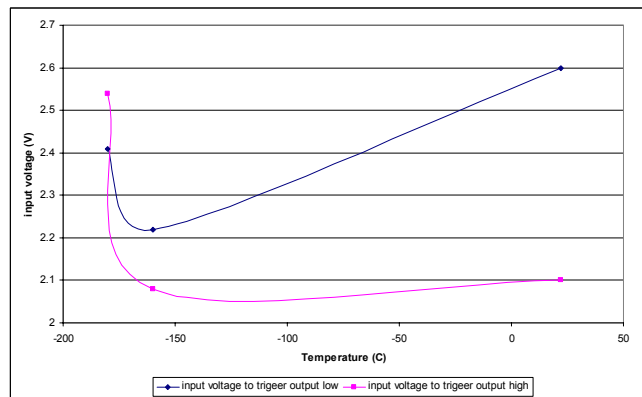
Figure 47. Input voltage to trigger output high and output low as a function of temperature.

Figure 47 shows the input voltage to trigger the output high and the input voltage to trigger the output low as a function of temperature.

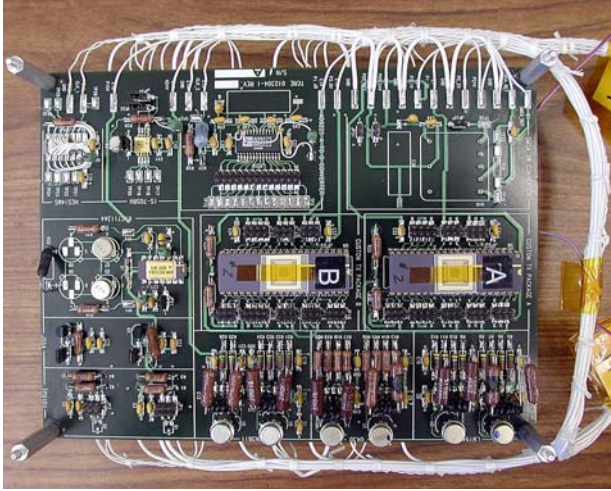
Figure 48. Top view of board A.

The 1000-hour cold soak test was performed within a cryogenic chamber at a constant -150°C with temperature fluctuation of $\pm 5^{\circ}\text{C}$ for a total of 1000 hours. All the test devices were characterized at time zero, before the cold test started. The cold test was stopped at 100, 300, 500, 750 and 1000 hour points for intermittent characterization. All characterization was performed at room temperature.

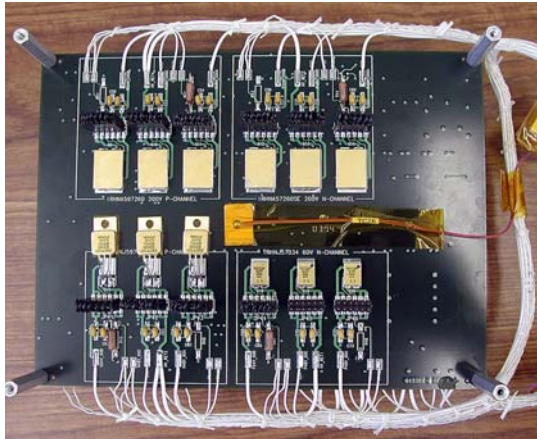
Figure 49. Bottom view of Board A.

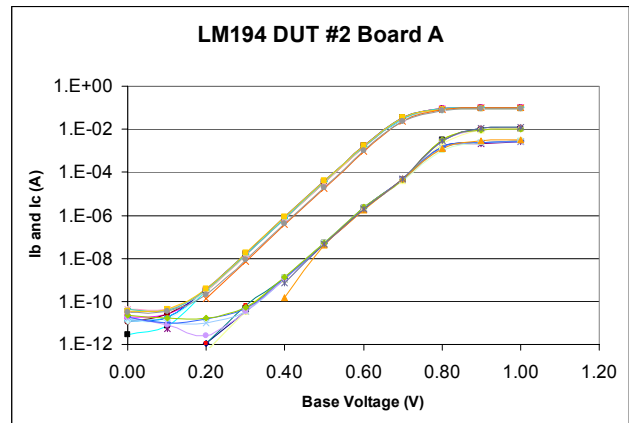
Figure 50. Representative gummel plot for LM194.

when V_{be} is from 0.3V to 0.7V is very small, but there is a shift when V_{be} is greater than 0.7V.

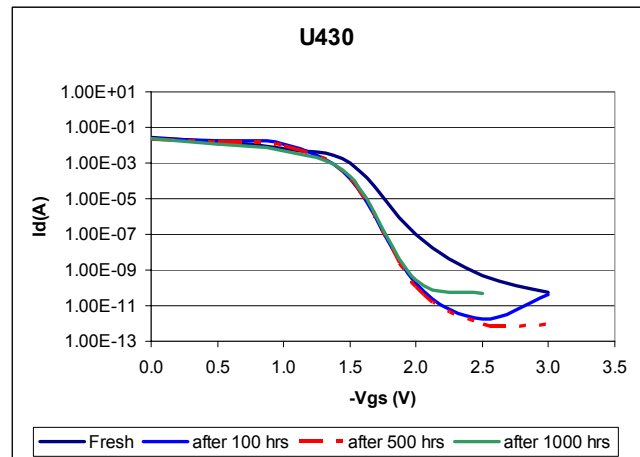
Figure 51. Turn-off voltage for U430.

U430: No noticeable degradation for U430 turn-off voltage when $V_g < 2.5\text{V}$ for devices on board. Turn-off voltage shifted less negative after the first 100 hrs for devices on board A, shown in Figure 51.

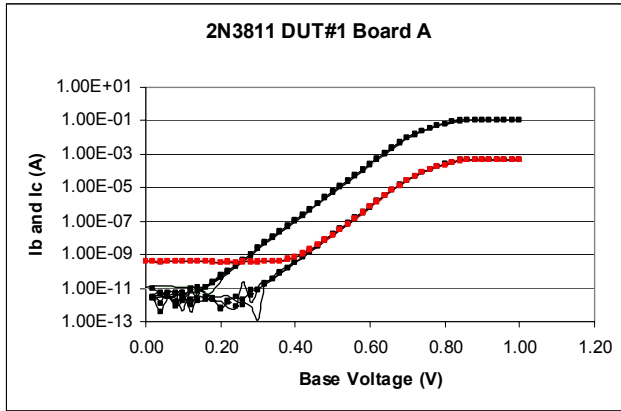
Figure 52. Representative gummel plot for 2N3811 on board A.

2N3811: Shown in Figure 52, devices on board A started to have up to 1nA leakage current at low V_{be} bias (less than 0.5V). No obvious degradation for devices on board B and C.

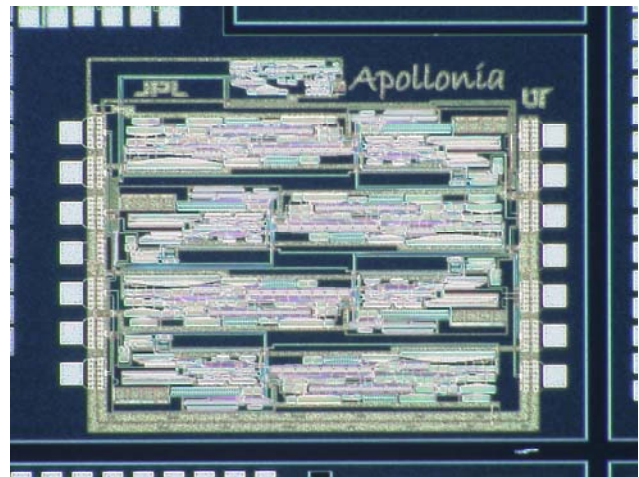
Figure 53: Quad Op-Amp

Design-for-reliability methodology was applied to a Quad Operational Amplifier circuit design for the wide temperature range application to ensure long term reliability. The Quad Op-Amp is shown in Figure 53. Hot carrier aging is the major intrinsic reliability concern at low temperatures; therefore, hot carrier tests were performed on the both NMOS and PMOS transistors from the SOI5 process at temperatures of -120 and -160°C. It was observed that PMOS hot carrier aging lifetime was two orders of magnitude greater than NMOS lifetime; therefore, the minimum channel length determination was focused on NMOS only.

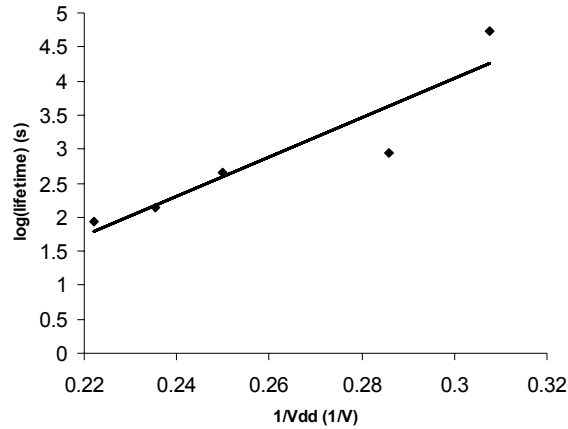
Figure 54. 0.35um NMOS hot carrier aging lifetime at -160°C.

Figure 54 shows that hot carrier aging lifetime for 0.35μm NMOS as a function of drain bias, with failure criterion defined as 10% maximum transconductance change based on QOA circuit requirements.

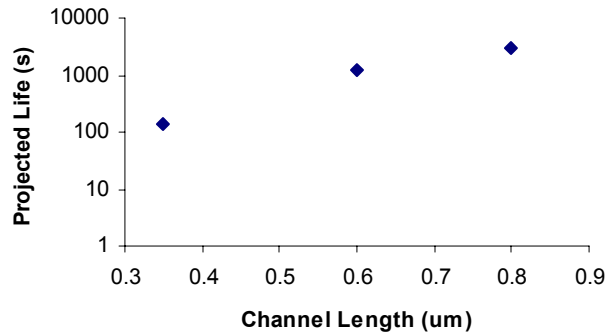
Figure 55. Channel dependence of NMOS hot carrier aging lifetime at -160°C.
